EXPERIMENTAL EVALUATION REPORT

Thin-Whitetopping Bonded Composite

Project No.: STPP 20-1(6)0, P-20, C000020; Highway 16, Milepost 0-0.6

Date of Evaluation: August 2007

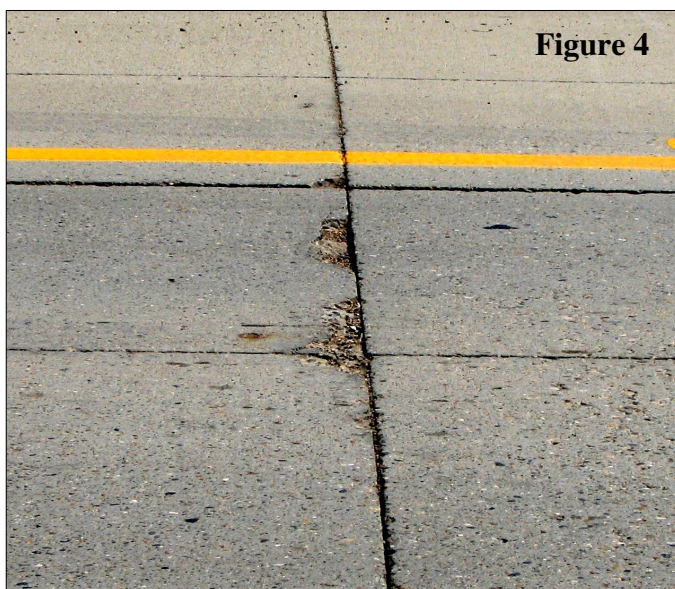
Several areas on the project are showing signs of wear and tear with slight spalling at panel saw cuts, to date minimum occurrences but gradually appearing. Figure 4 is an example of the spalling.

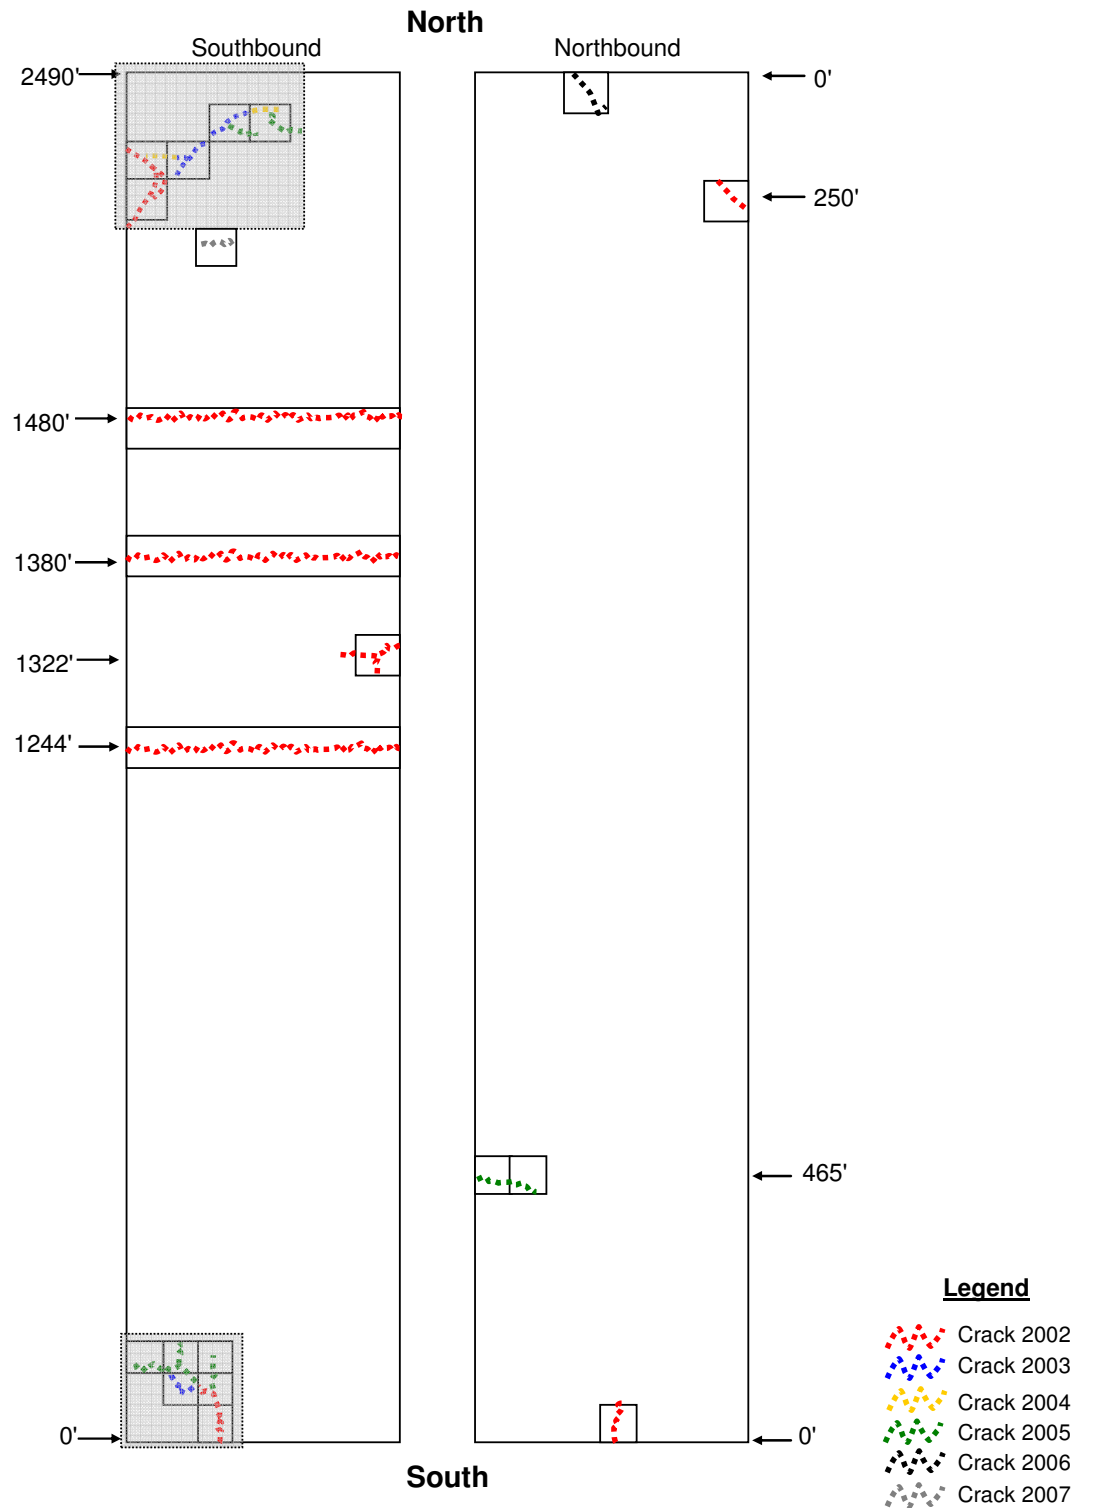
Glendive Whitetopping Representative Crack Map

A visual inspection of the entire project was performed to document all types of surface cracking and distress. Photographic documentation of some of the cracks, recent repairs, as well as a representative crack map is included in this report. Note that the crack map is strictly an interpretation of progressive distress during the evaluation phase of the project, it is not to scale. Currently three transverse cracks are present on this project, all in the southbound lane. Location as follows (footage counted from the south end of the project going north), #1 at 1244' (541m), #2 at 1380' (420m), and #3 at 1480' (451m), see crack map at end of report. Note that these cracks developed soon after placement
